RESEARCH MEMORANDUM

EXPERIMENTAL INVESTIGATION OF AIR-COOLED TURBINE BLADES
IN TURBOJET ENGINE

XIII - ENDURANCE EVALUATION OF SEVERAL PROTECTIVE
COATINGS APPLIED TO TURBINE BLADES OF
NONSTRATEGIC STEELS

NACA RM E53E18

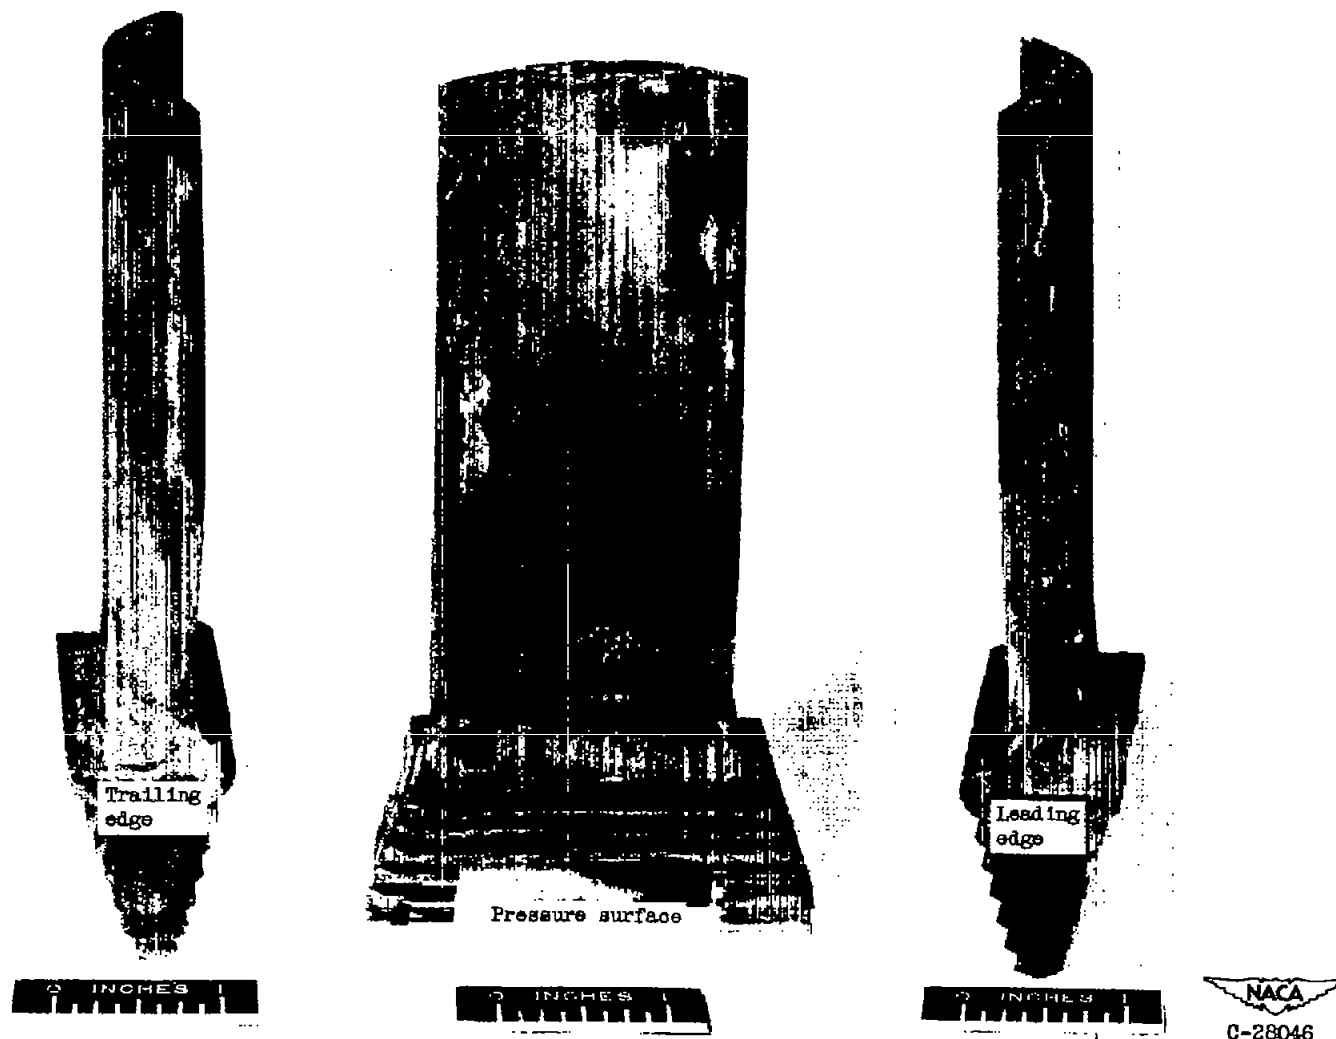
Blade 1. - The coating on blade 1 was considered a failure after 7.3 hours of rated engine speed operation, and investigation of the blade was concluded at the end of that time. Figure 3(a) shows several views of the blade at the conclusion of the tests and it can be seen that the coating chipped away from the leading- and trailing-edge regions of the blade. There is also an area near the root in the midchord region of

the blade where the coating flaked off. The failure of the coating apparently was a function of the metal temperature, as the greatest damage to the coating occurred at the leading- and trailing-edge regions where the metal temperatures are the highest (see fig. 2). More coating was removed from the leading edge than from the trailing edge, probably because the high-velocity combustion gases impinge directly upon the leading edge and their erosive action is greatest in this area.

(a) Blade 1 after 7.3 hours (20 cycles plus 2.3 hours at rated test conditions) with coolant-flow ratio of 0.048. Complete breakdown of coating along leading and trailing edges evident.

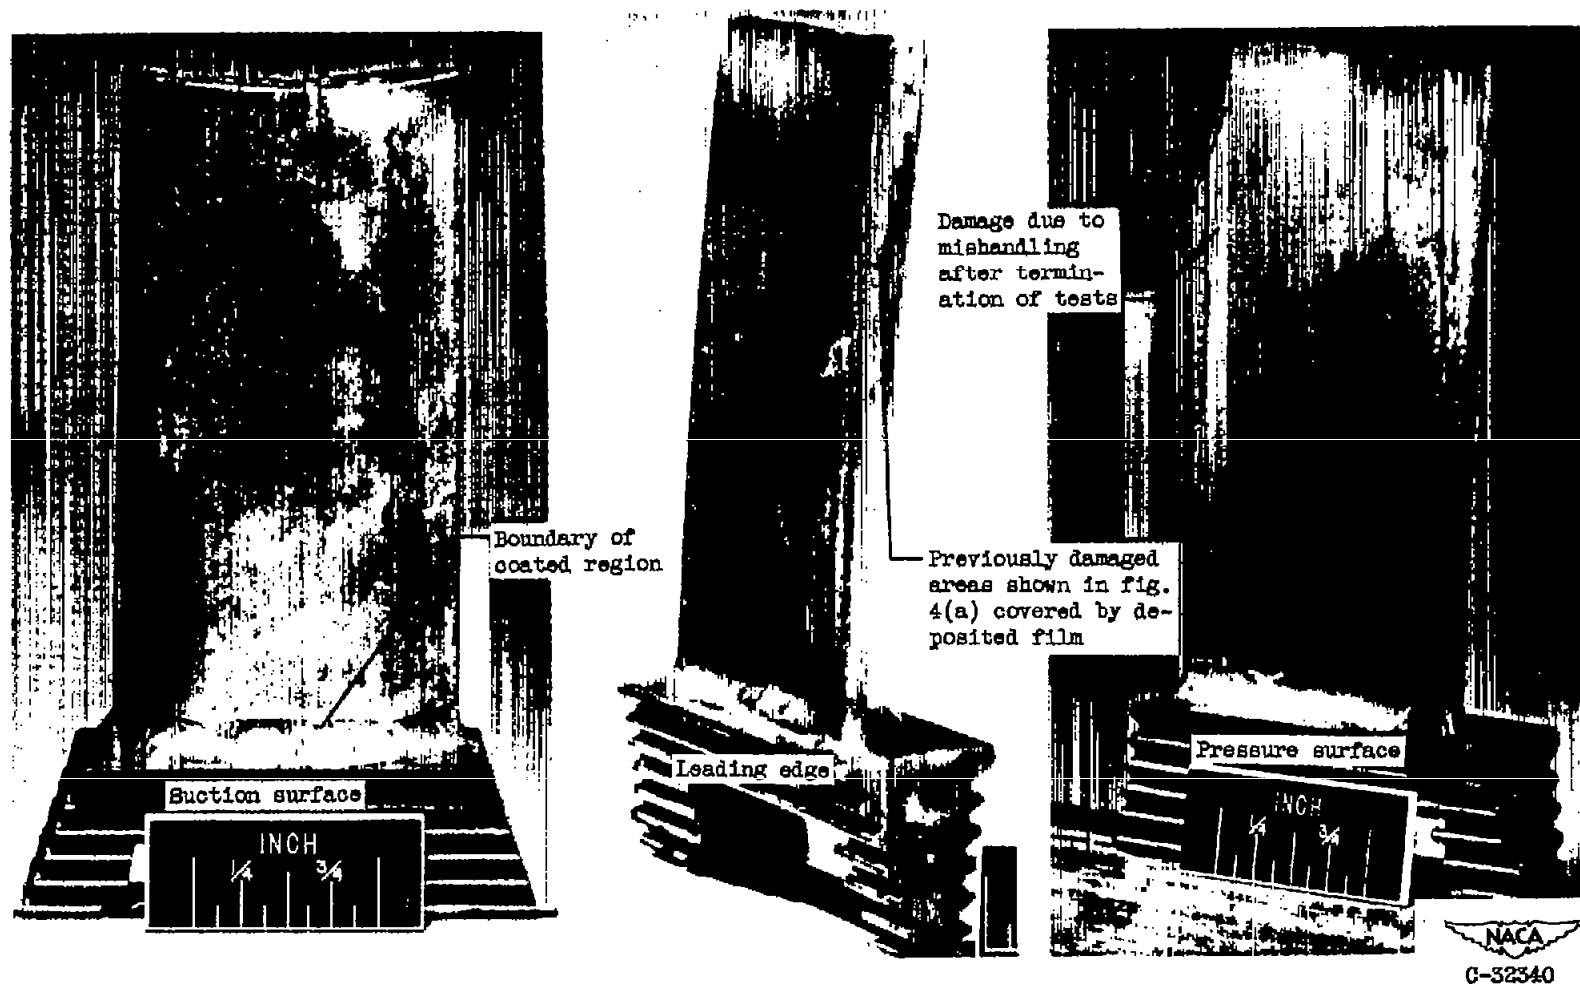
(b) Blade 5 after 100 hours at rated test conditions with coolant-flow ratio of 0.048. Coating in excellent condition except where hit by foreign objects.

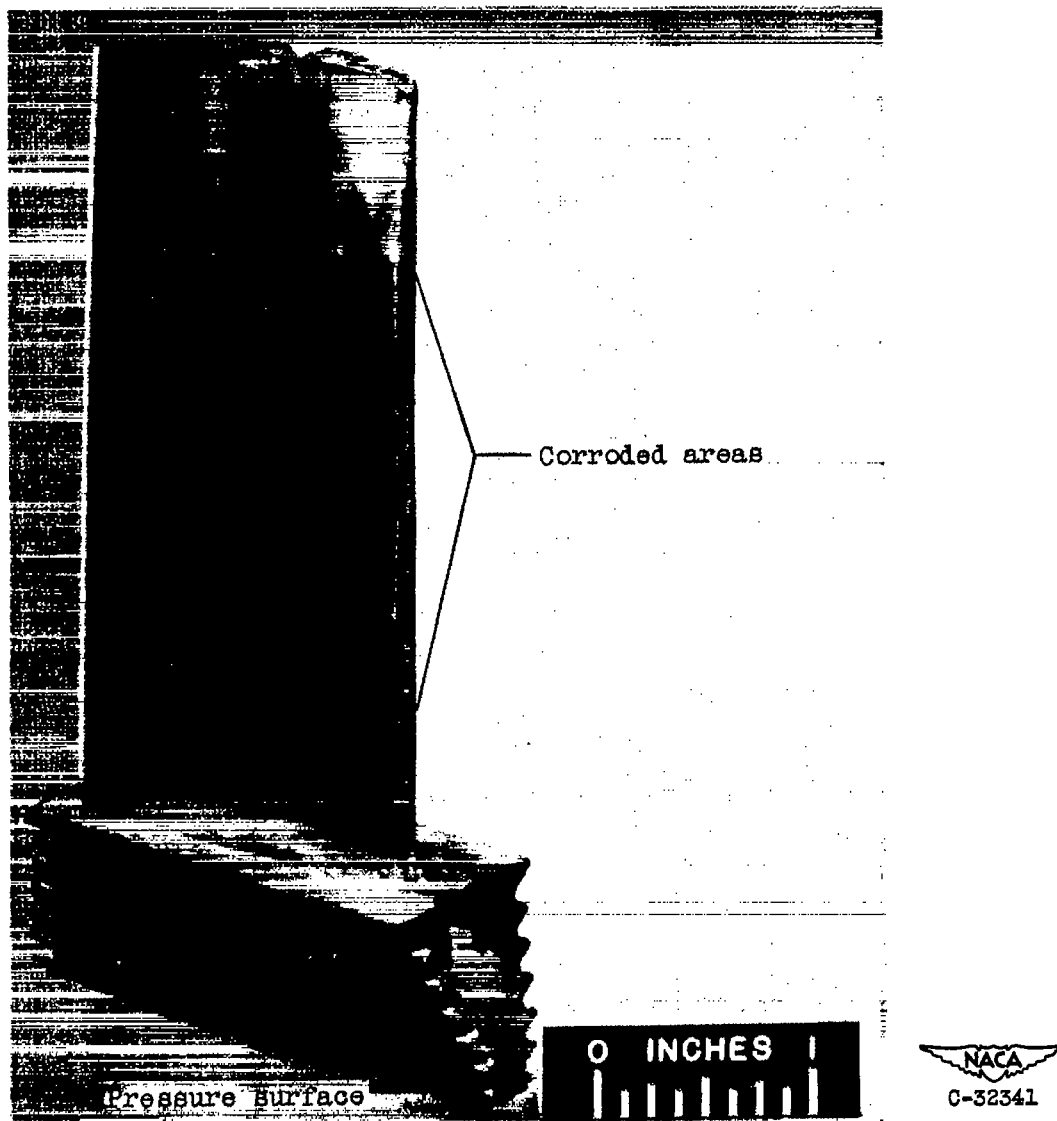
Blades 6, 8, 9, 11, 12, 14, and 15 were operated at rated test conditions for periods of time ranging from about 11.5 hours to as much as 25 hours before the coatings were considered failures. The failures of the nickel coatings were all similar, that is, the nickel began to blister and chip away from the leading- and trailing-edge regions of the blades as shown in figure 5(a). As operation of the blades was continued, corrosion of the parent metal in the leading and trailing edges occurred and the nickel coating also began to fail in the midchord region of the blade. The coatings generally began to fail first in the tip region of the blade after about 11 to 15 hours of rated engine speed operation. Temperature and centrifugal force are both factors in the breakdown of the coating. Failure usually progressed rapidly along the leading edge of the blade, where erosion also seemed to be a factor in removal of the coating. A blade that exhibited extensive erosion and corrosion at the leading edge is shown in figure 5(b), which is a photograph of blade 6 at the completion of 44 hours at rated test conditions. The failure of the coating along the trailing edge was generally less extensive than that at the leading edge, probably because the scouring action of the combustion gases is not so great in this region. Also, trailing-edge temperatures are somewhat lower than those at the leading edge. The temperature level of the blade material influences the life of the nickel coating; failure of the coating in the cooler midchord region was much more infrequent than at the leading and trailing edges (see fig. 2). Frequently, no evidence of failure was observed in the midchord region. The lower temperature apparently enables the nickel to adhere and provide the necessary corrosion resistance.

(a) Blade 12 after 55.3 hours at rated test conditions with coolant-flow ratio of 0.03 to 0.048. Coating completely eroded away at leading edge and blistered and flaked in scattered areas over entire blade.

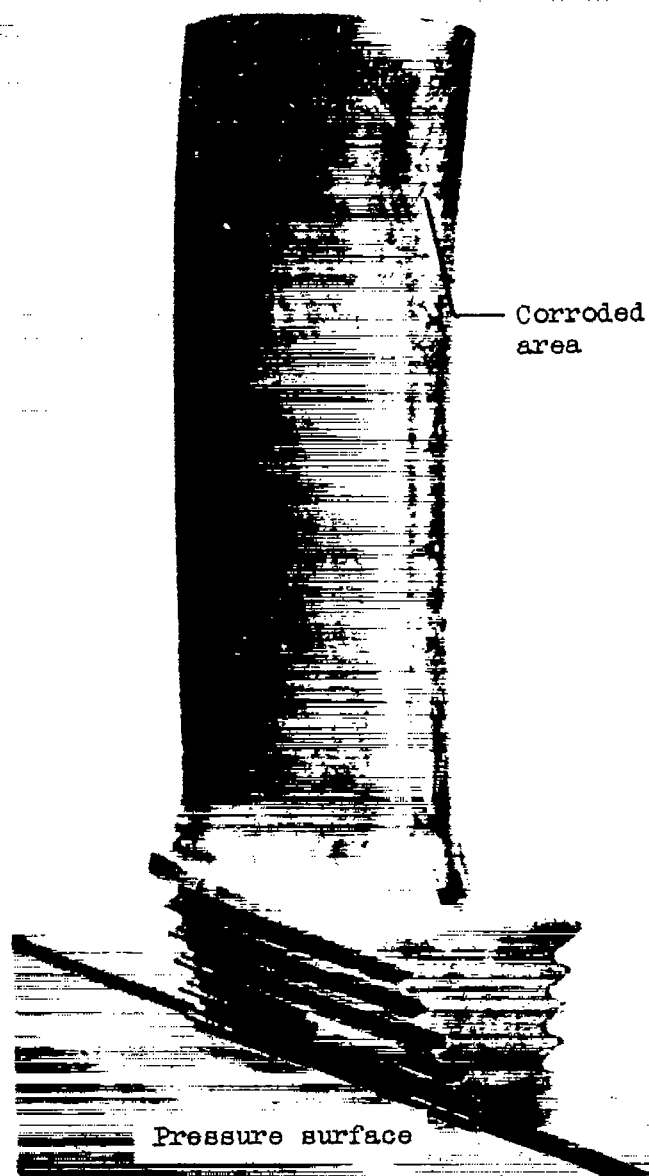
(b) Blade 6 after 44 hours at rated test conditions with coolant-flow ratio of 0.048. Coating chipped and eroded on leading edge and eroded along trailing edge. Leading edge corroded near tip.

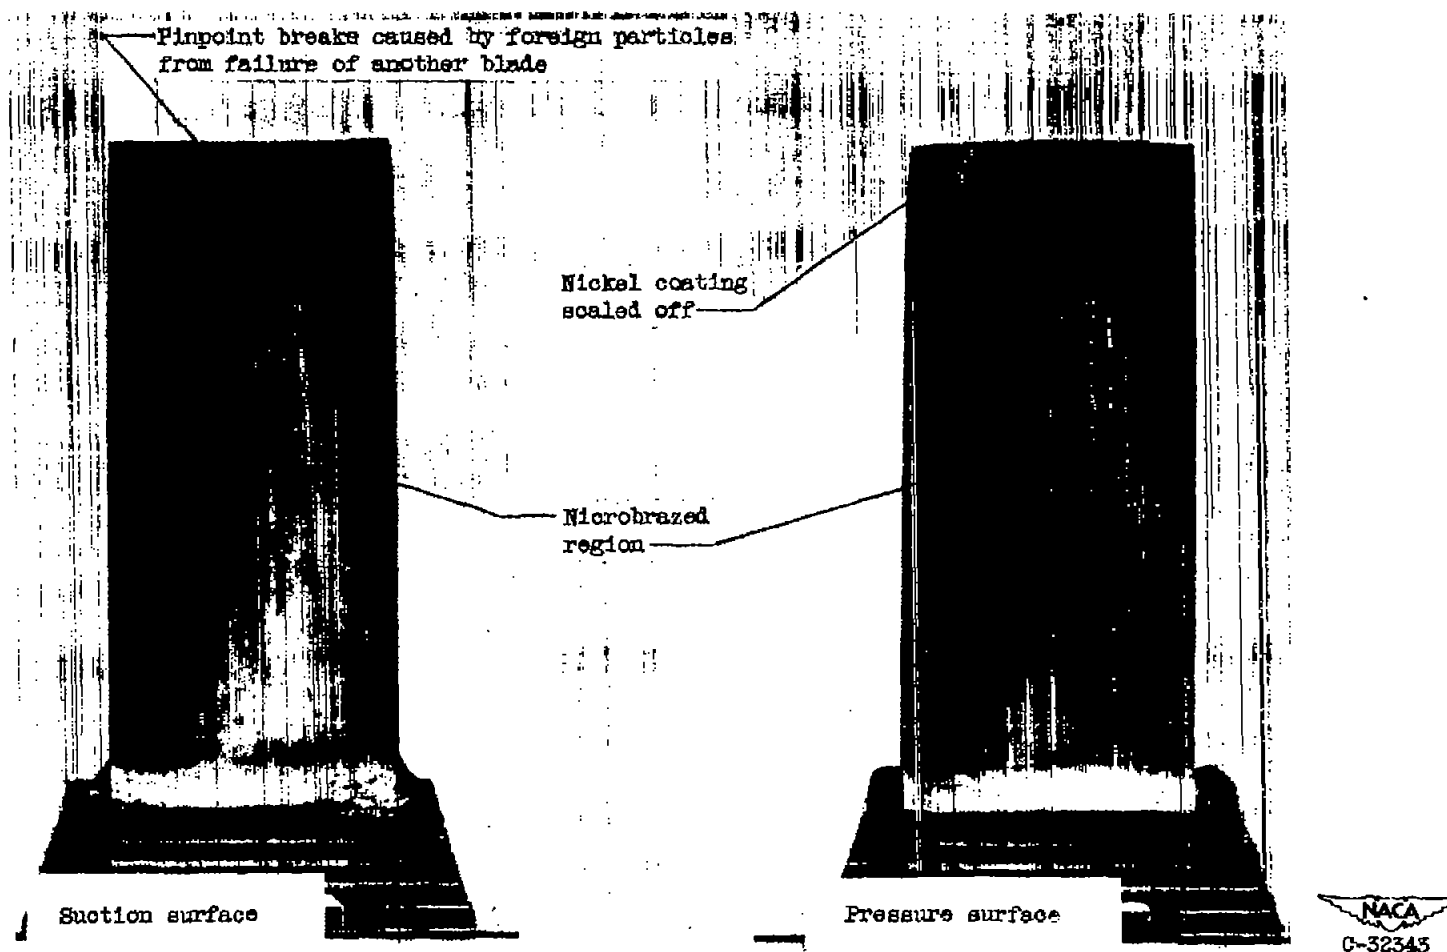
Figure 6. - Nickel-coated blade 20 with Microbraz along leading edge. Blade after 100 hours at rated test conditions with coolant-flow ratio of 0.048. Leading edge and midchord region in excellent condition.

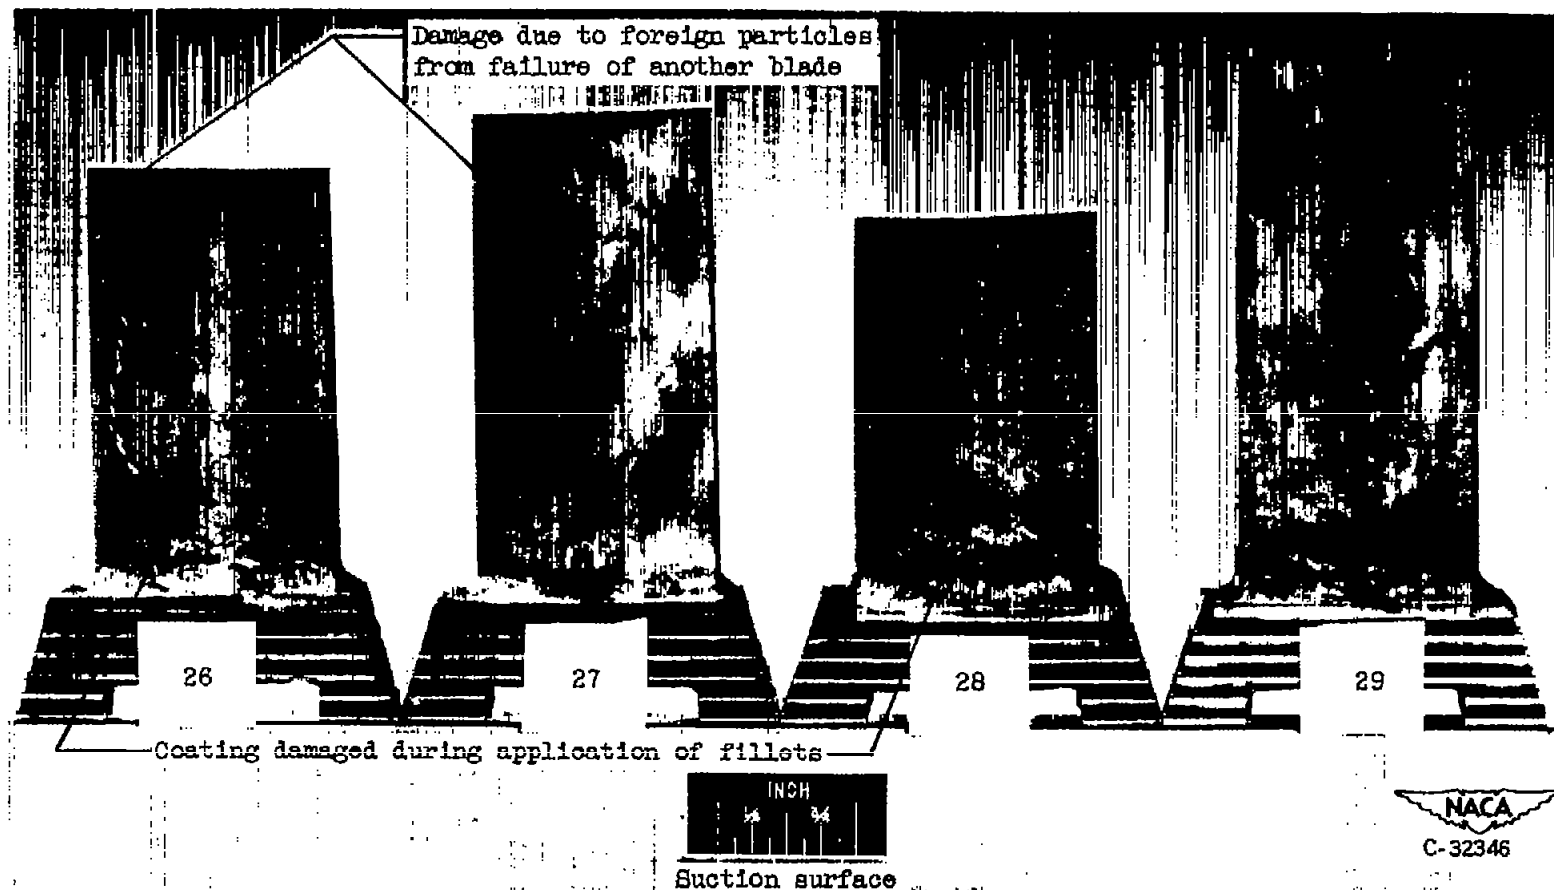
(a) Blades during early stages of endurance running with coolant-flow ratio of 0.03. Time on blades 26 and 27, 23.8 hours; on blade 28, 18.1 hours; on blade 29, no time. Surfaces in excellent condition.
